NSWCCD-TR-65-97/18 April 1997

Technical Report

An Experimental Investigation of the Ultimate Strength of Stiffened Panels

- Volume 1, Results and Analyses

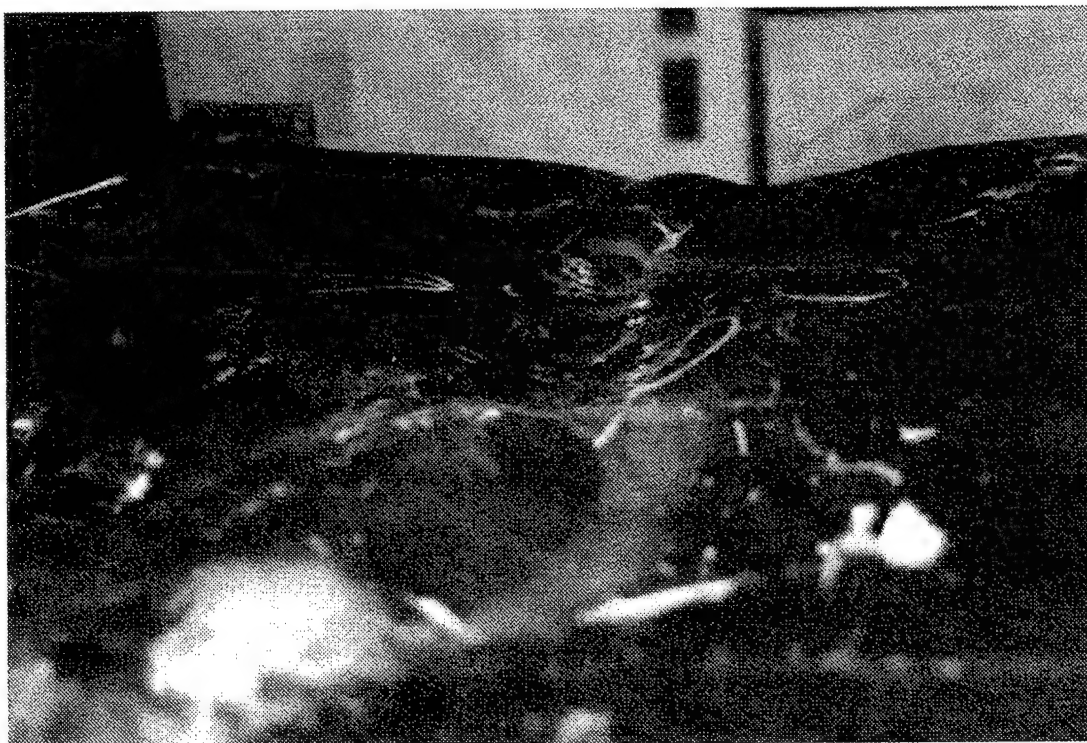
Grillage 1094 also collapsed by a Mode II failure. The ultimate collapse stress was 35,772 psi. No lateral pressure was applied during this test. Collapse occurred in the center bay between the transverse frames with an alternating pattern of deflections noted in the plating. Figure 23a shows the center bay of the test specimen after testing. Note the pattern of deflections

in the plating and the apparent rotation of the stiffener flanges. Figure 23b shows the same region, but on the plate side of the panel. The amount of deflection of the plating and stiffeners can be seen in Figure 23c. The location of the plate failure is similar to that on Grillage 0494, but the pattern of plate deflection is mirror imaged (on Grillage 0494, the plate deflects down on the edge vice up on Grillage 1094). Figure 23d is a detail of the plate deflections at the center bay of Grillage 1094.

Figure 23a - Post Test Deformations on Stiffener Side of Grillage 1094

Figure 23c - Post Test Side View of Grillage 1094

Figure 23d - Close-up of Plate Side Deformations

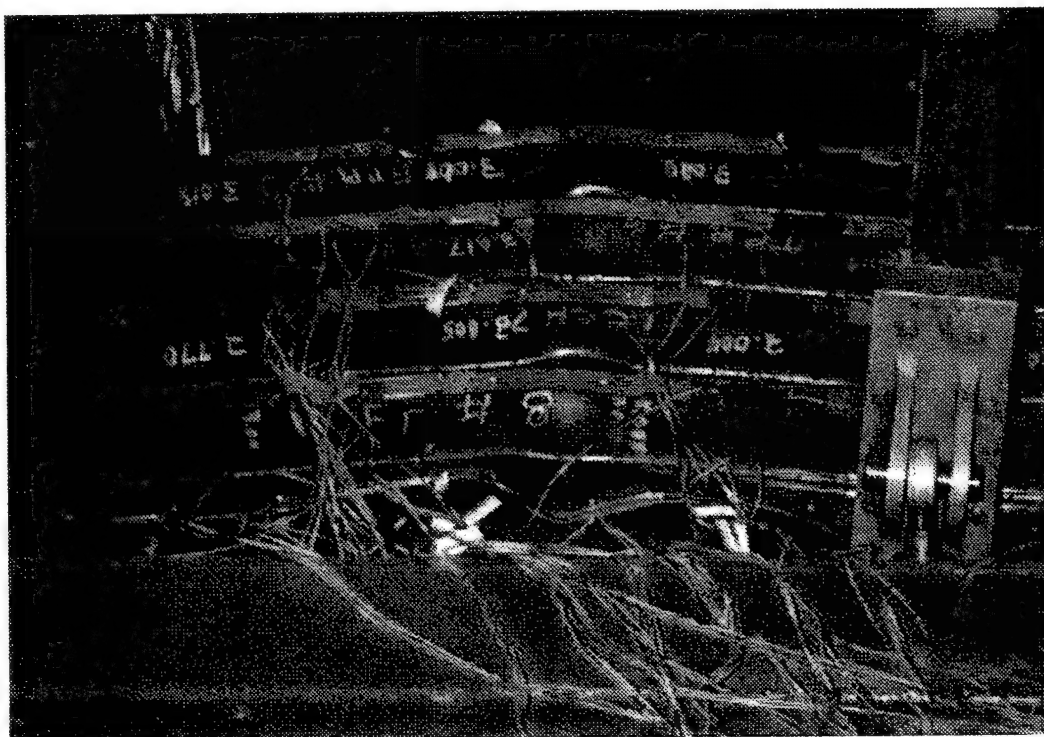
Grillage 0595 was loaded with a constant 5 psi of uniform lateral pressure. The ultimate collapse stress was 36,104 psi and the failure was, as expected, a Mode II mechanism. The uniform lateral pressure caused an initial deflection at the midspan of the stiffeners of 0.011-inches and an initial deflection of the midspan of the center plate of 0.015-inches. The collapse started in the center panel of the center bay and proceeded outward to the stiffeners. Figure 28a shows the port side of Grillage 0595 in the Test Fixture after collapse. Figure 28b shows the

pattern of deformation experienced by the stiffeners and the plating. Figure 28c is a detail of the deflection pattern. Note how the pattern alternates across the grillage and how the web of the stiffeners are affected by the plate deformation. The failure of the stiffener flanges in the forward bay can be seen in Figure 28d. The combination of the fixed end boundary conditions at the grillage ends and the upward deflection of the stiffeners in the center bay put the stiffener flanges in the end bays in compression and cause a local buckling mechanism.

Figure 28a - Grillage 0595 in Test Fixture After Collapse

Figure 28b - Center Bay of Grillage 0595 Showing Stiffener and Plate Deformation

Figure 28c - Detail of Plate and Stiffener Deformations on Grillage 0595

Figure 28d - Stiffener Failure in the Forward Bay of Grillage 0595
